Information for floor installers and owners of timber flooring

This information is provided for guidance when a timber floor has been inundated with mud and silt laden water typical of what has occurred in Queensland in January 2011. It does not apply to inundation from sea water and is limited to appearance of performance aspects of the exposed flooring product.

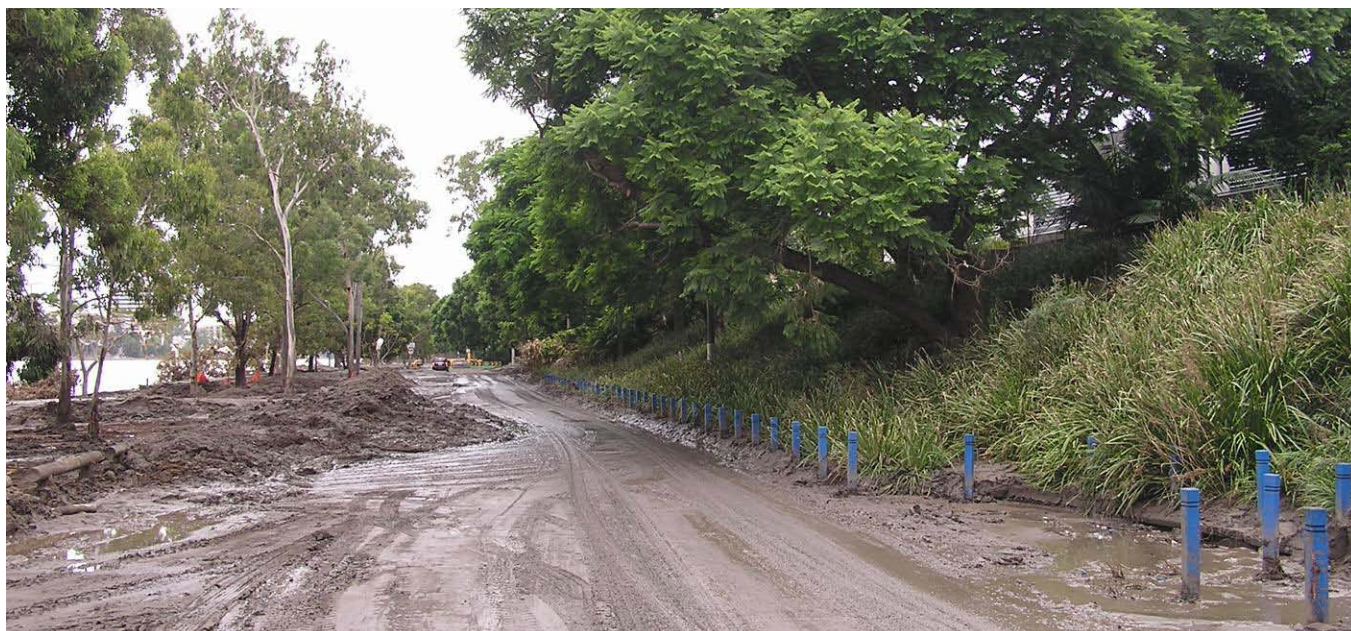
Mud and silt from the Brisbane River in 2011. The water rose to height exceeding the embankment to the right and inundated businesses and apartments.

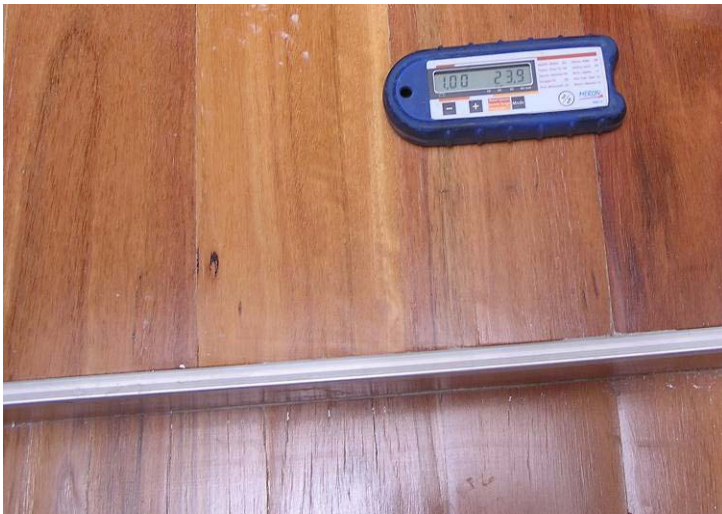
This engineered floor direct stuck to the slab was submerged in the Brisbane flood of 2011 with about half a meter of water over the floor. This photo is about 10 days after the flood. The plywood core layer remains high in moisture content but the floor although having a crowned appearance is still firmly fixed to the slab. The water had also resulted in some expansion in the floor and checking (or splits) in the surface. Greater moisture penetration was evident at board end joints and board ends abutting walls and doorways. A similar direct stuck floor that had been removed had minimal mud and silt beneath.
